TOWN OF SHARPSBURG

STORM DRAINAGE STUDY 2022

TEG Project No. 20210173

January 8, 2023

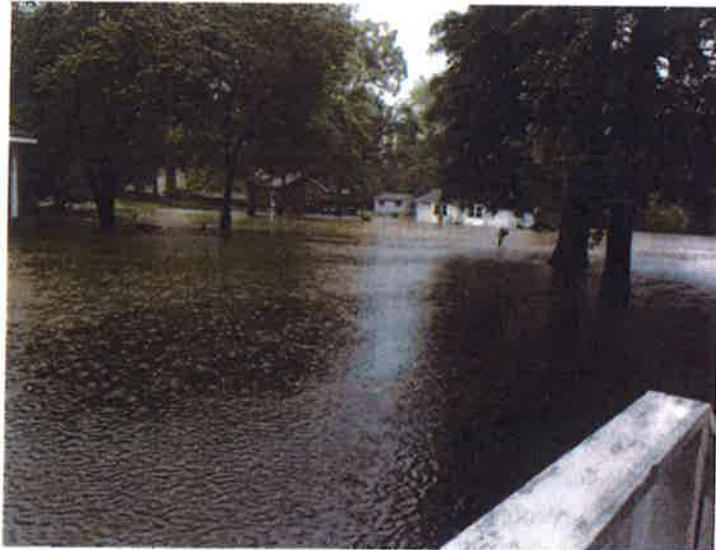
Figure 1-Creekside Drive Flooding

This study was first conceived as a response to ongoing flooding in the Creekside Drive area but once public discussions about flooding issues arose, other areas known to the Town leadership and citizens were brought forward as problems that must be addressed. The Town decided on a review of the known problems throughout the Town and through a Request for Proposals process, The East Group was retained to study the problems, gather information, perform analysis, and formulate proposed solutions for the Town. The results of this study are the subject of this report.

Northern Basin – Based upon the study, we recommend the replacement of the culverts at Oak Forest Drive, at Holley Drive, and channel regrading along Creekside Drive and new wing walls for the culverts. Work to improve the inlet conditions for the Oak Forest Drive Culvert will be required as a large and poorly channelized flow arrives at the culvert and some of the flood backwater occurs due to the inability to conduct this flow into the culvert crossing.

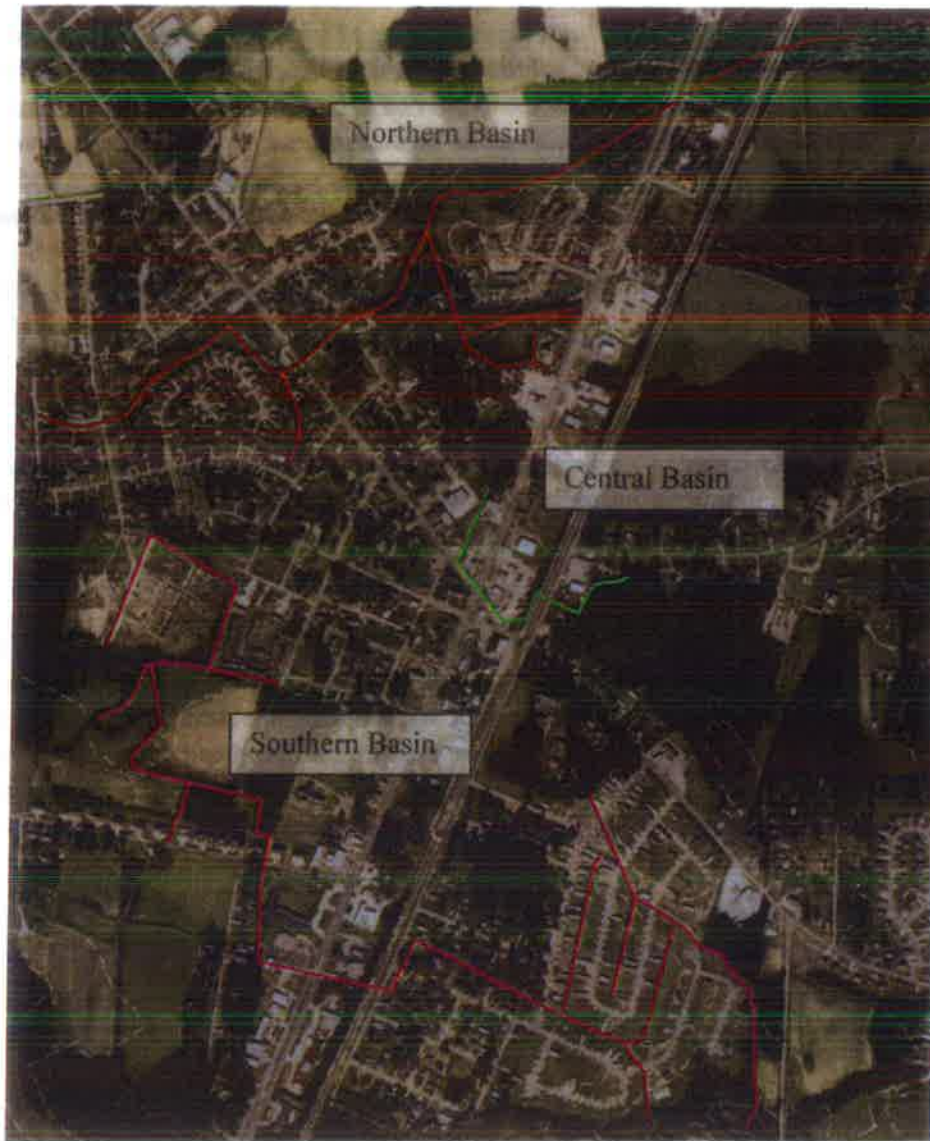
Figure 2- The Three Drainage Basins

For the sake of organizing and analyzing the drainage of the Town we divided the report to discuss individually the three natural drainage basins of the Town. There is a separate independent basin to the north, one to the south, and a smaller, central basin. The drainage pathways of these three basins are shown below in Figure 4. The drainage for the northern basin is shown in red, the drainage for the southern basin is shown in purple and the central basin drainage pathway is shown in green.

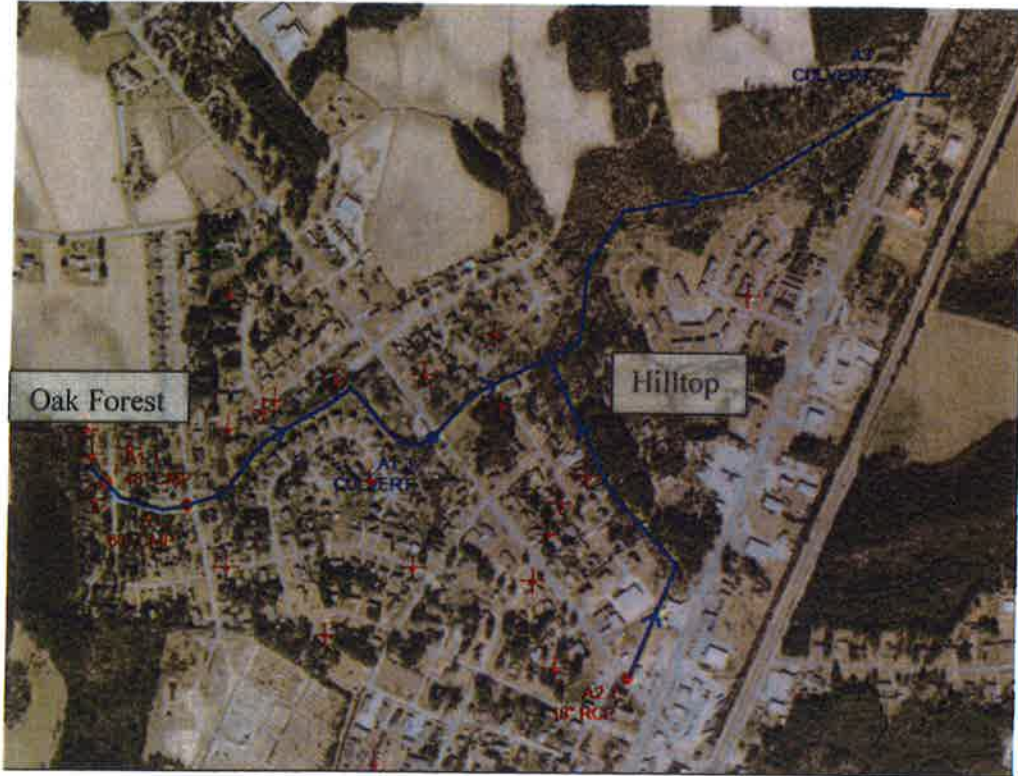
Figure 3-North Drainage Basin

North Drainage Basin - To the north, a natural channel known as Cokey Swamp receives runoff from 981 acres or approximately 1.5 square miles of basin and we designate this drainage system, which acts independently from the remainder of town, as the North Drainage Basin. The system serving the North Basin begins in the fields east of Oak Forest Drive and flows through an open channel to a culvert crossing of Oak Forest. The system continues westward through an open channel with culverts at Holley Drive and then to an open channel just north of Kentucky Avenue to a culvert at Mill Branch and from there through an open channel north of Hilltop on to US301 to the CSXT Railroad ditch and culvert. The system has experienced flooding issues in the past at Oak Forest Drive. In the aftermath of Hurricane Floyd, 6 to 8 free-standing apartment units were cleared at Hilltop Drive and removed as part of a FEMA Hazard Mitigation effort

to reduce the chances of future flooding. Several of the culverts or of corrugated metal piping and equipped with masonry headwalls with wingwalls. The wingwalls of the culverts at Oak Forest and Holly Drive appear to be failing and are also restrictive of flow. In general, the culverts appear to be nearing their useful life due to corrosion and abrasion, but more importantly, they are generally undersized for the flow that they are tasked with carrying.

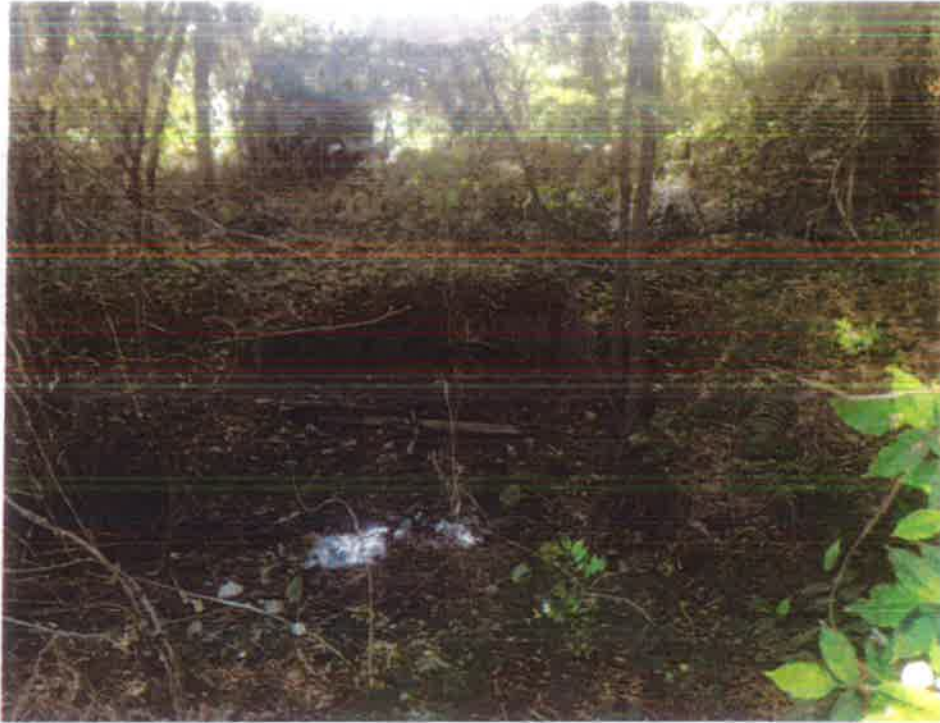
Figure 4-South Drainage Basin - 30" CMP just upstream of Speedy Wok

South Drainage Basin - The South Basin includes approximately 484 acres are delivered to the US Highway 301 right-of-way through two main channels: One of the channels originates in agricultural fields and delivers its runoff eastward to an underground storm sewer system serving an existing apartment complex

through an existing 24-inch CMP at the existing Speedy Wok on US Highway 301.

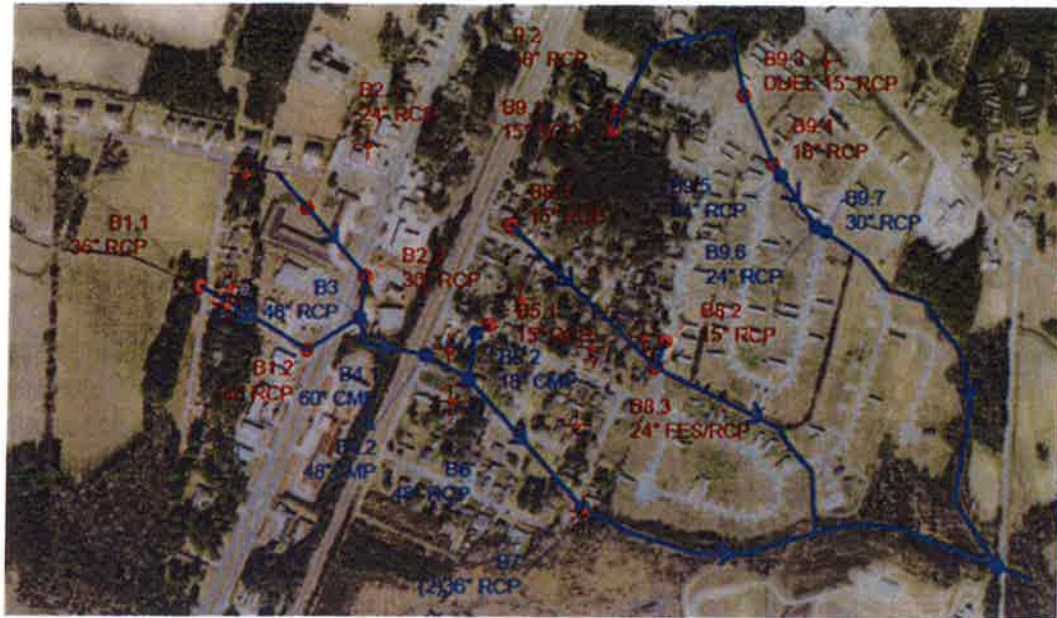
Figure 5-South Basin Drainage Pattern

A drainage ditch serving Sharpe Road also continues eastward to an open channel which flows to a point directly behind the Bright Leaf Motel. Underground piping conducts this flow under the Motel building and parking lot to the US Highway 301 road ditch. This surface runoff converges to a single culvert crossing of US 301 and outfalls to a channel that follows the Dollar General property to the CSXT rail line. A double corrugated metal pipe (CMP) carries the flow under the railroad and to an underground system that extends eastward between Dawes Drive and Martin Luther King Jr. Circle where it turns southeastward to cross under Armstrong Drive and Queen Street to the vicinity of the Brickyard Pump Station location.

The pipe system discharges to an open channel which flows approximately 2,000 LF to the east to a double CMP culvert at Heffner Road. Between Brickyard pump station and Heffner Road, a large mobile home park served by a series of open ditches drains to and connects with the main drainage channel serving the South Basin. A field reconnaissance of the South Basin revealed numerous issues related to the condition of the system. The Bright Leaf Motel tributary of the South Basin is problematic because public drainage relies on a pipe system under a private property building (Bright Leaf Motel). The drop inlets leading up to the building are dilapidated. The slabs surrounding the building are settling indicating voids underneath the slabs and thus leaks or failure in the piping. Should the piping collapse, the drainage of Sharp Road would be disconnected and stopped from effectively draining that area of Town. In addition, the Greenleaf Street area, which is drained by the enclosed storm sewer passing through the Speedy Wok property, has suffered from historic flooding. We were informed at the public meeting that residents of Greenleaf were evacuated by boat in the aftermath of Hurricane Floyd. Obviously, the storm sewer is undersized and this is borne out by the analysis included in this report. At SE Railroad Street and Dawes Drive, several reoccurring sink holes occur on the storm sewer which appear to be the result of corrosion of the CMP pipe at that location. This pipe system is the main drainage system for the South Basin and its failure would result in near cessation of drainage action for the South Basin resulting in routine flooding of all upstream areas including the motel, the Dollar General, Sharpe Road and all of the southern US Highway 301 area in that vicinity. Separate from those issues, many of the main line pipes in the South Basin are reverse grade and thus drain sluggishly.

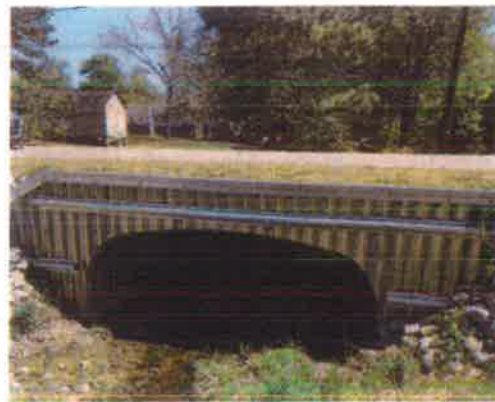
Figure 6-Mill Creek Drive Replacement Culvert

An improvement inlet with wing walls is needed at Oak Forest to conduct the runoff into the pipe and channel system. Some problems were reported downstream at Judge Street on the north bank of the channel between Holly Drive and the Ann Beasley Park. Some of those problems may be due to the culvert under Mill Creek. Fortunately, the culvert under Mill Creek was replaced in recent years and it appears to be of

adequate capacity for the 10-year storm. Perhaps the problems noted occurred prior to the Mill Creek Drive culvert replacement. We would recommend completing the known to be required improvements as soon as funding allows and monitoring the channel to see if the problems reoccur. Some additional study at the time of design of the culvert replacements may help confirm the scope of work for future improvements downstream of Holly Drive if necessary.

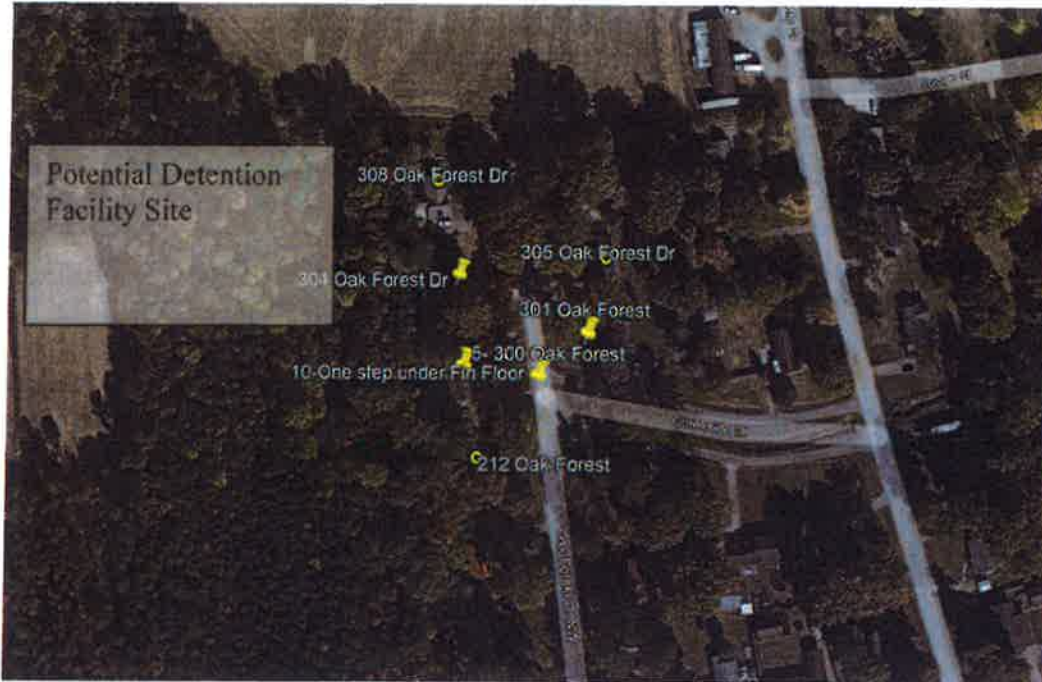
Figure 8-Potential Detention Facility - North Basin

In the case of the Oak Forest detention project, it would require the facility to be designed to control a drainage basin of more than 700 acres. The southern, Greenleaf Road detention facility would control about 400 acres of drainage basin. Such significant facilities will be required to temporarily store hundreds of acre-feet of water to make a significant downstream impact. This may prove infeasible but it will more than likely be very expensive depending on the design storm and intended discharge target. Since the infrastructure downstream has

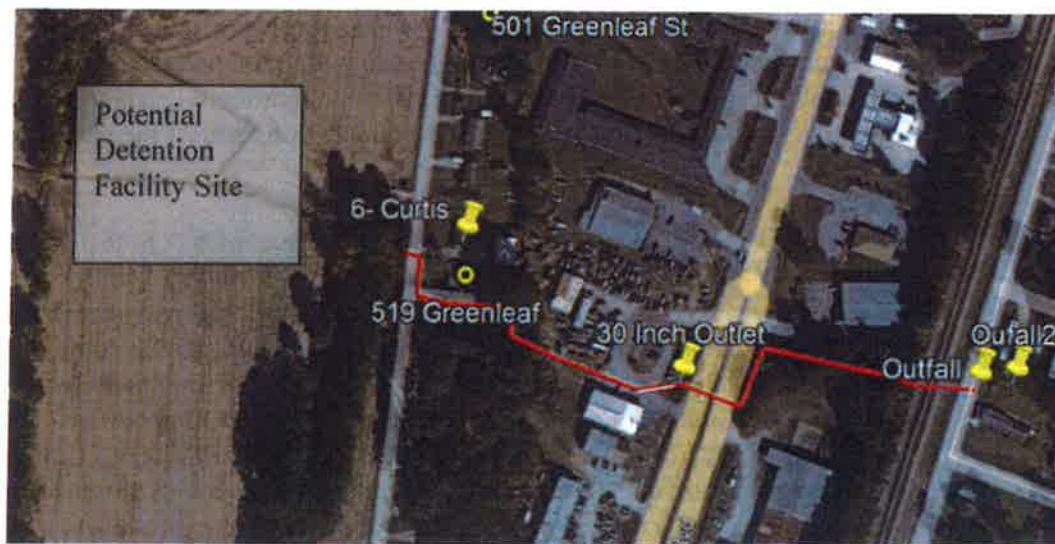
Figure 9- Potential Detention Facility – South Basin

significant components that are beyond their useful life, such a scheme does not eliminate the need for downstream culvert replacements and channel improvements. That being the case, the CWMTF funding will likely be an add-on to the real work of infrastructure replacement and upgrade that is needed. This is not likely a significant funding source for the most significant drainage problems for the Town but it might be a part of a solution in the future. Especially if the upstream properties develop.
