TOWN OF SHARPSBURG

STORM DRAINAGE STUDY 2022

TEG Project No. 20210173

January 8, 2023

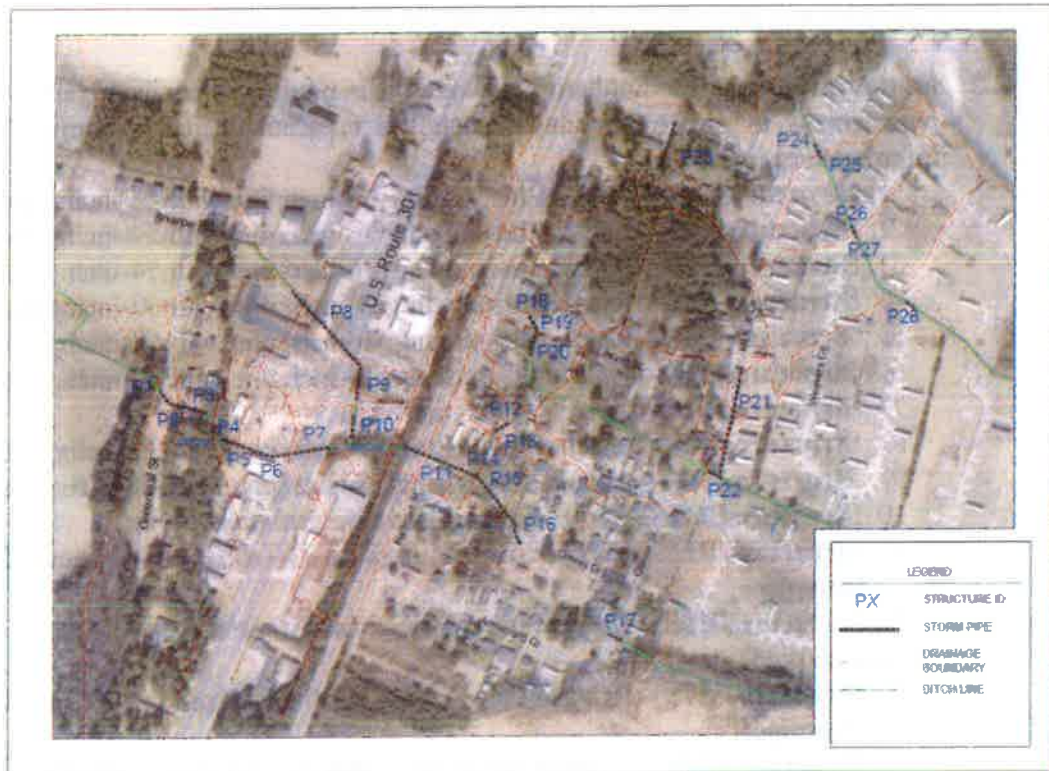
In addition, there is approximately 33 acres of drainage area coming off Sharpe Road to the Bright Leaf Motel. There is an existing drainage canal that feeds this runoff to a pipe system that runs under the motel. This pipe system is failing. A better approach would be to divert this runoff down Sharpe Road to the US Highway 301 drainage system. The runoff will wind up at the same location as it does now if diverted as proposed, but the route would no longer be under the building through the failing piping. This diversion would be very expensive and it is not clear without discussions with all parties and with legal

counsel what kind of cost-sharing arrangement for this work would be fair or achievable without further work. Refer to Map 4.2.16 in Attachment 1 for a view of this option. We would be glad to discuss it further. An arrangement with the motel owner, with NCDOT, and with the Town would be required to implement this drainage diversion.
